August 16, 2007

**Douglas County Public Works
100 3rd Street
Castle Rock, Colorado 80104**

**Subject: Preliminary Findings
Geotechnical Consultation
Surface Drainage and Sidewalk Chase Drains
Highlands Ranch Filing No. 122-U
Highlands Ranch, Colorado
Project No. DN42,518-145**

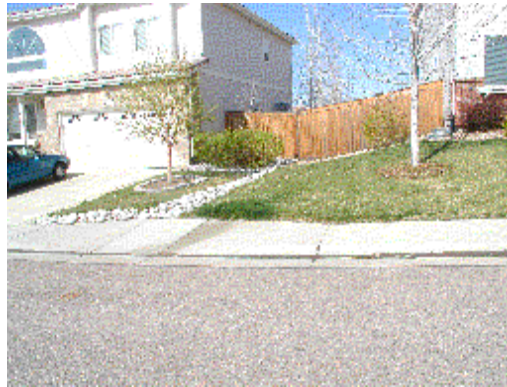
At the time of our initial site visit on March 27, 2007, landscaping irrigation had not yet begun. There had been rain in the area during the prior week. We observed most of the landscaping on the lots in Filing No. 122-U was healthy and appeared to be growing. In several locations, very moist to wet areas were observed in the front lawns, along with water flow over the sidewalk (Photo 1). We also observed several areas of water flow and algae growth (Photo 2). Chase drains (Photo 3) had been constructed within the sidewalk in some areas to allow water to flow from behind the sidewalk to the curb.

Photo 1 - Water flow across sidewalk

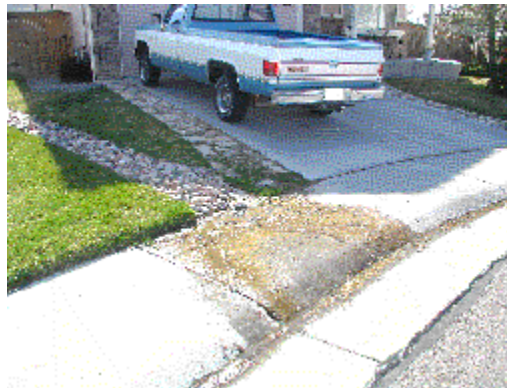
Photo 2 - Water flow and algae growth

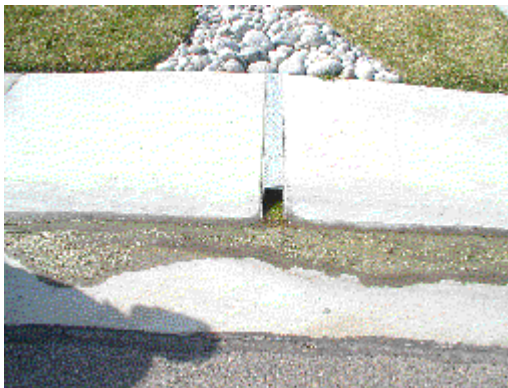
Photo 3 - Typical chase drain

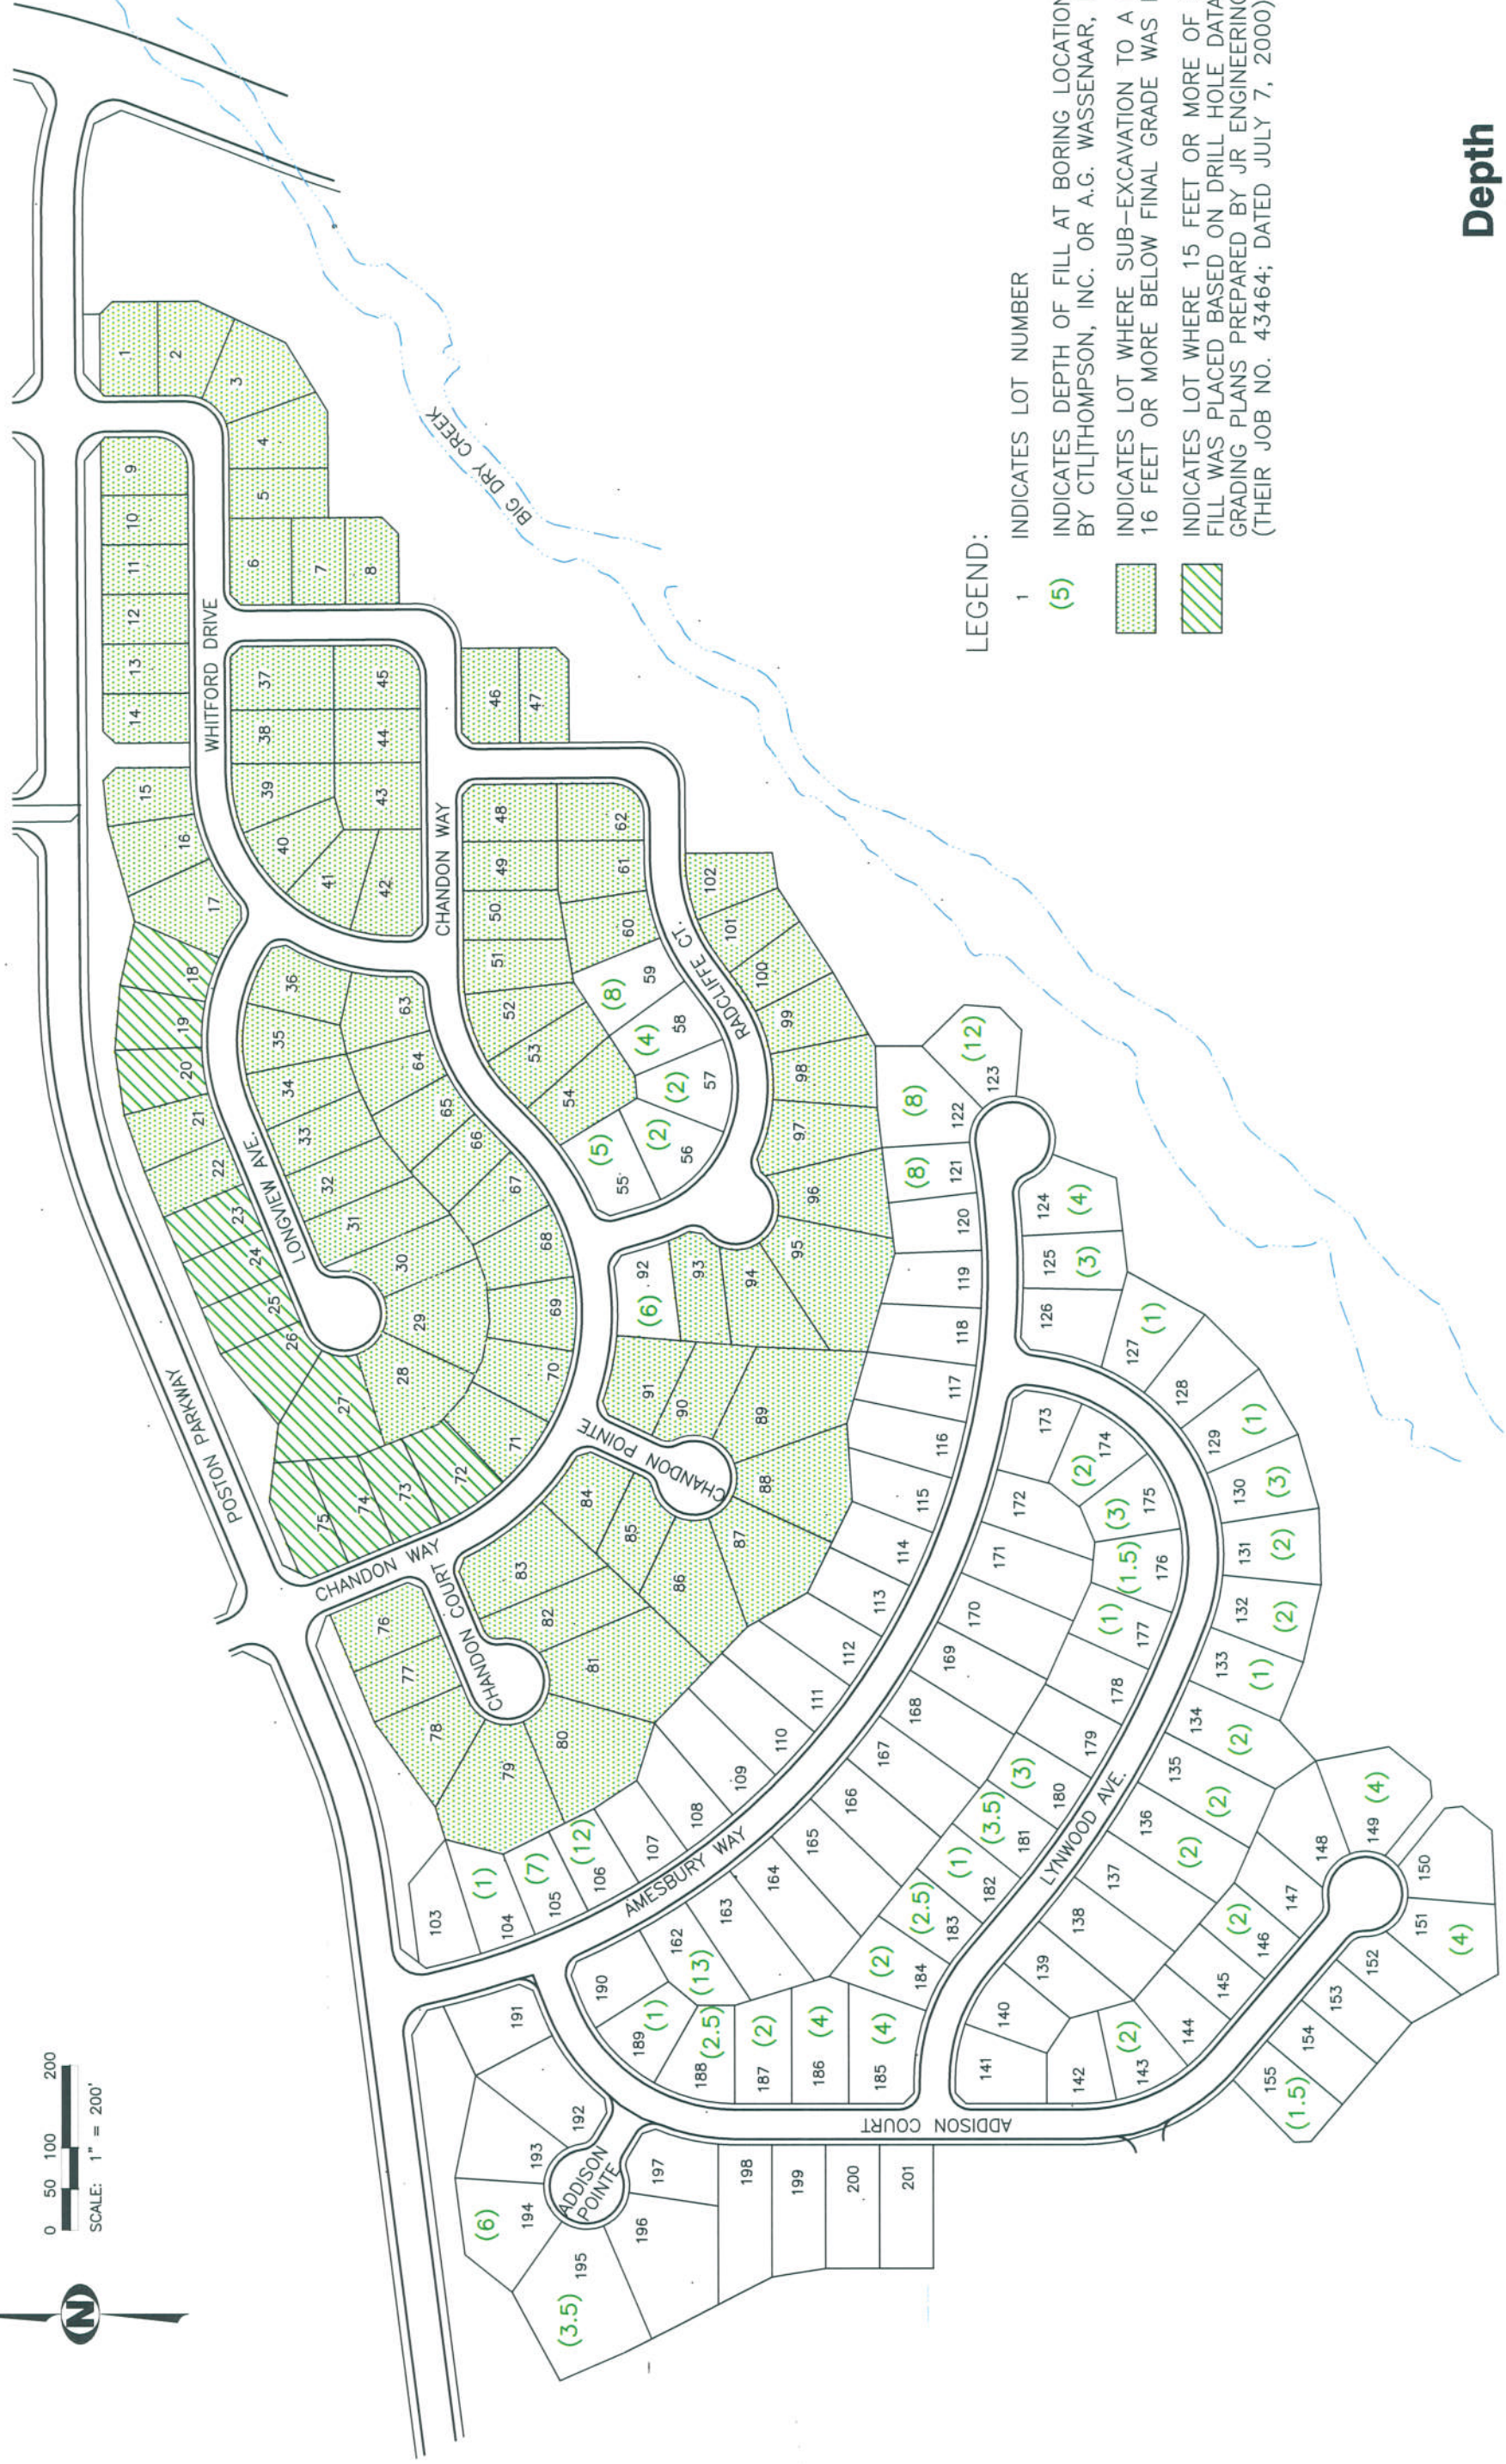
Depth of Fill

Depth of fill based on studies performed by our firm and A.G. Wassenaar is shown on Fig. 2. Depth to bedrock and estimated bedrock surface elevation are presented on Figs. 3 and 4, respectively. Measured depth to ground water is shown on Fig. 5. Estimated ground water surface elevation is shown on Fig. 6.

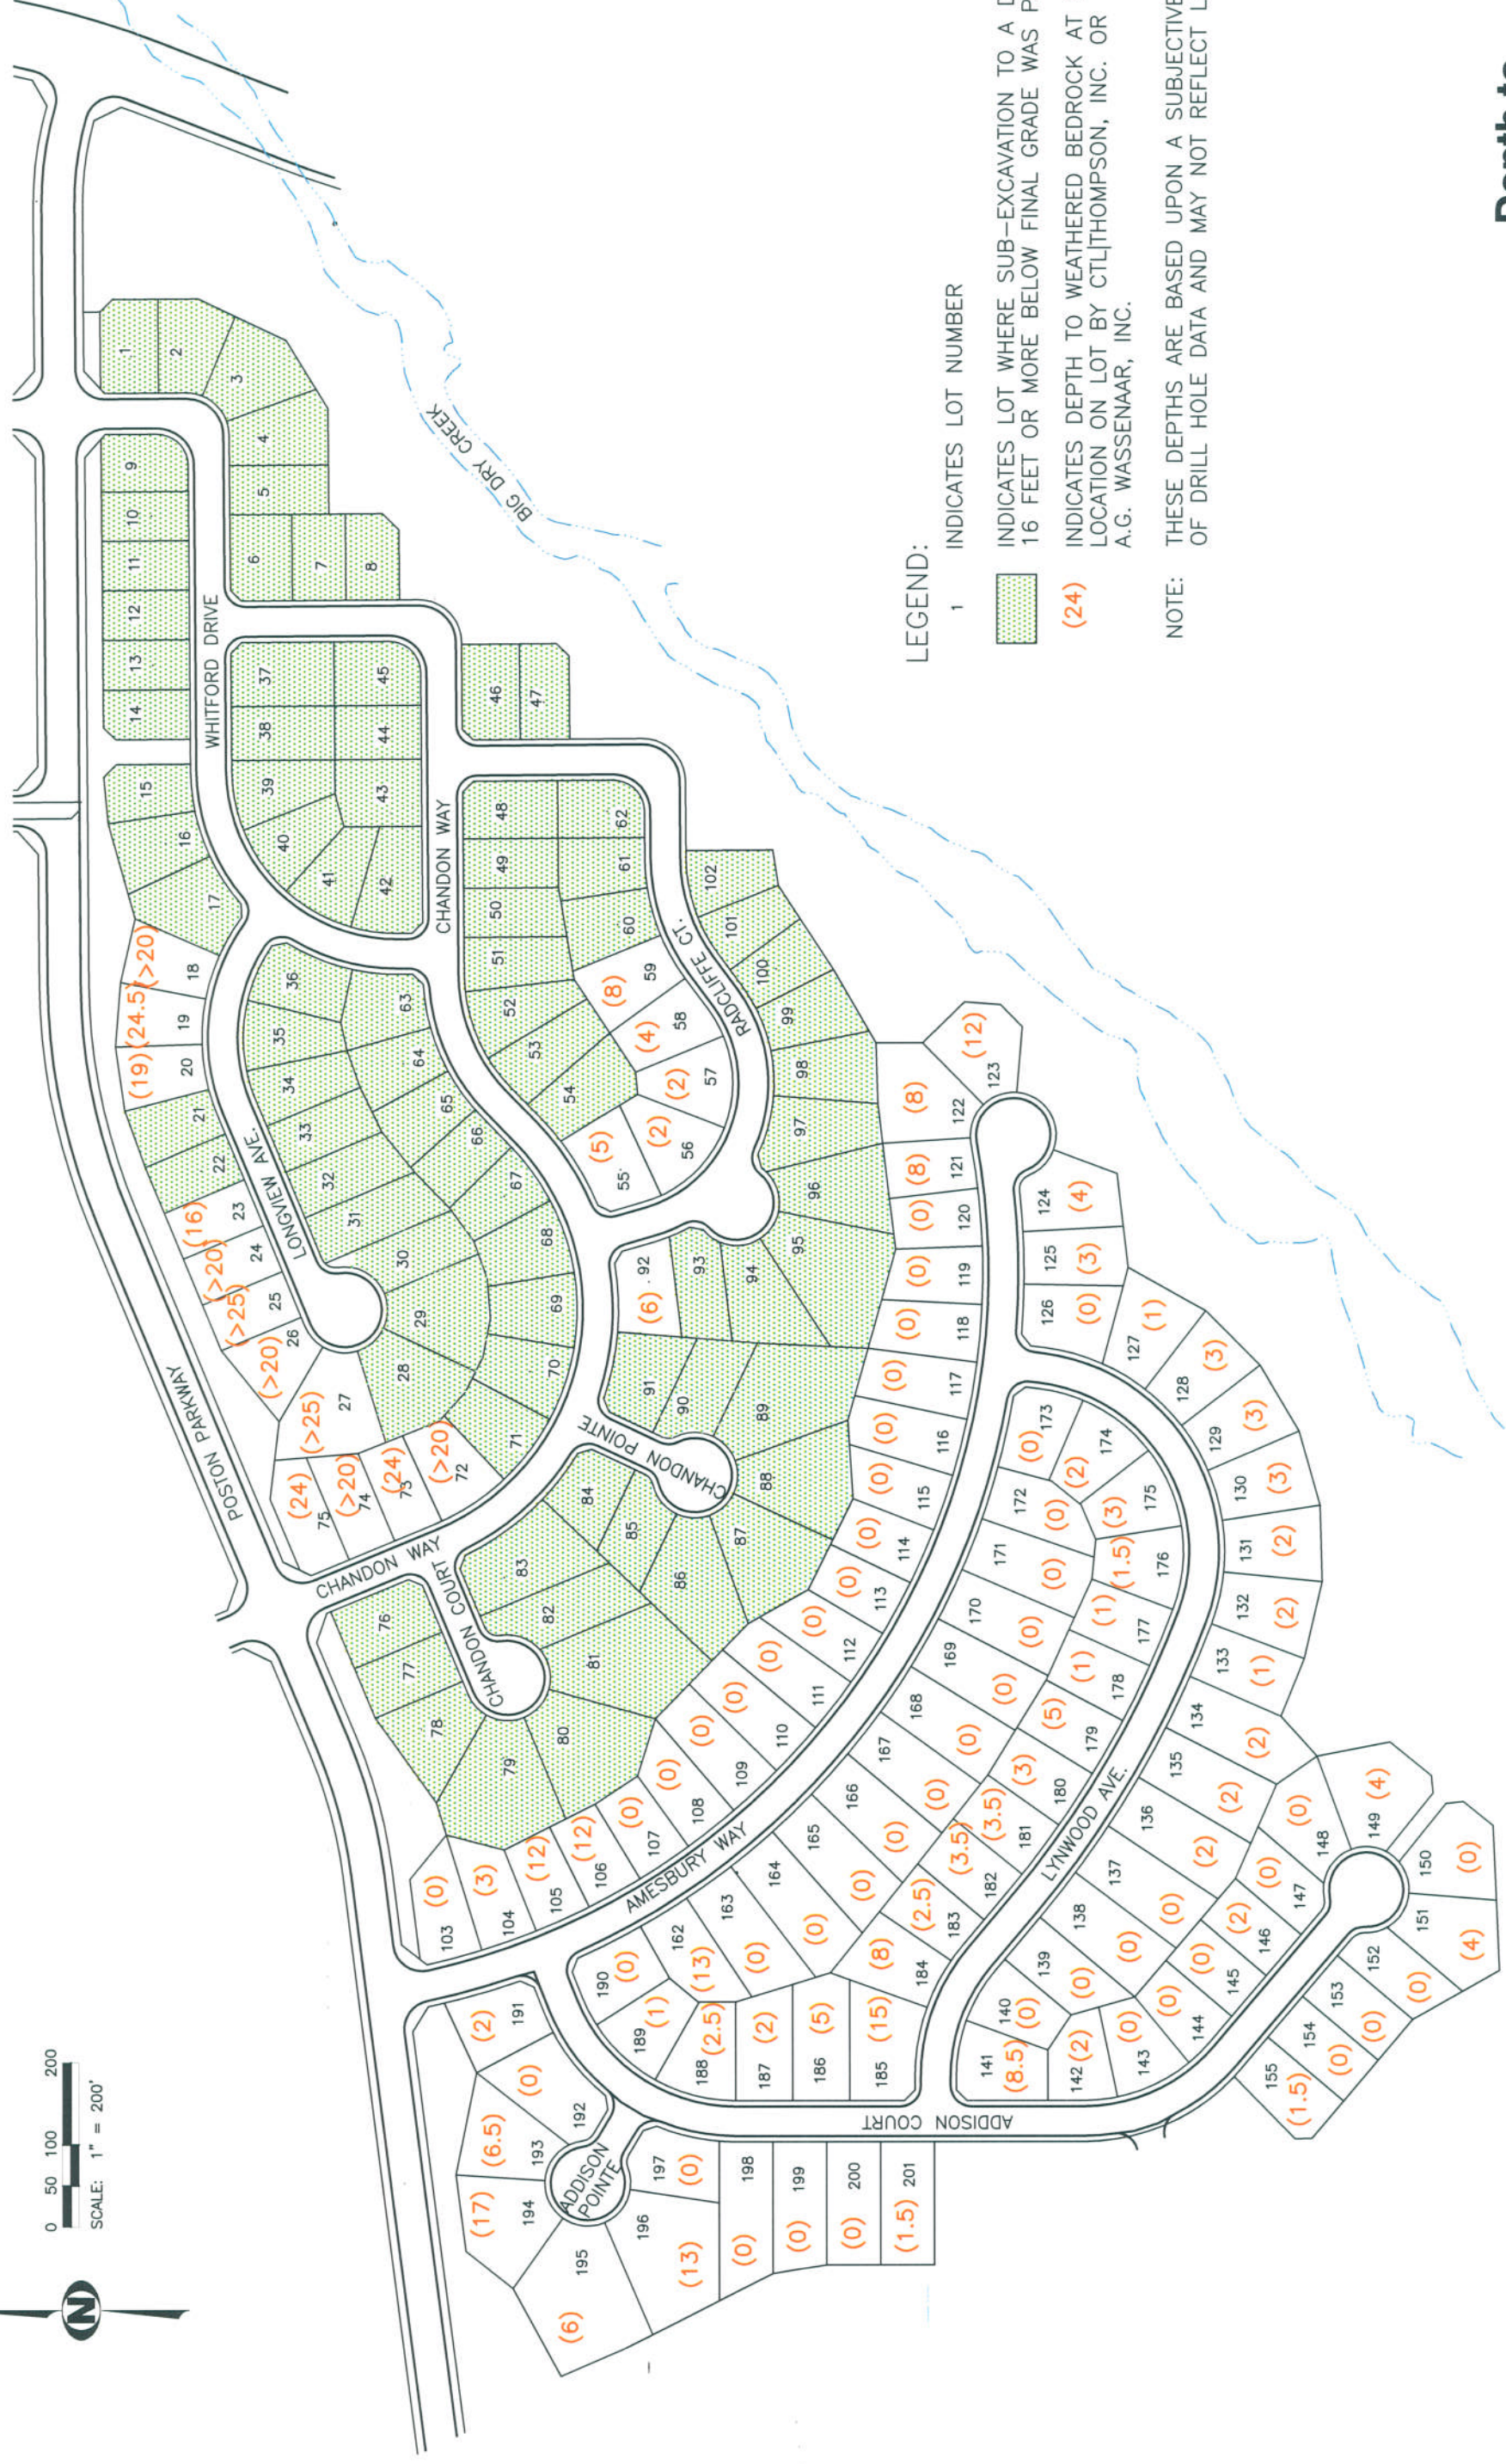
Our experience indicates ground water may flow or perch in comparatively permeable sandstone and above less permeable claystone bedrock surface. As shown in Table I, the bedrock depth under these 51 chase drain locations varies from at the ground surface to greater than 16 feet. The data does not reflect a conclusive correlation between the bedrock depth to the excessive surface runoff or the need for chase drains. It is possible that if seepage is intercepted by a basement excavation, water will be collected by the foundation drain and then pumped to the ground surface.

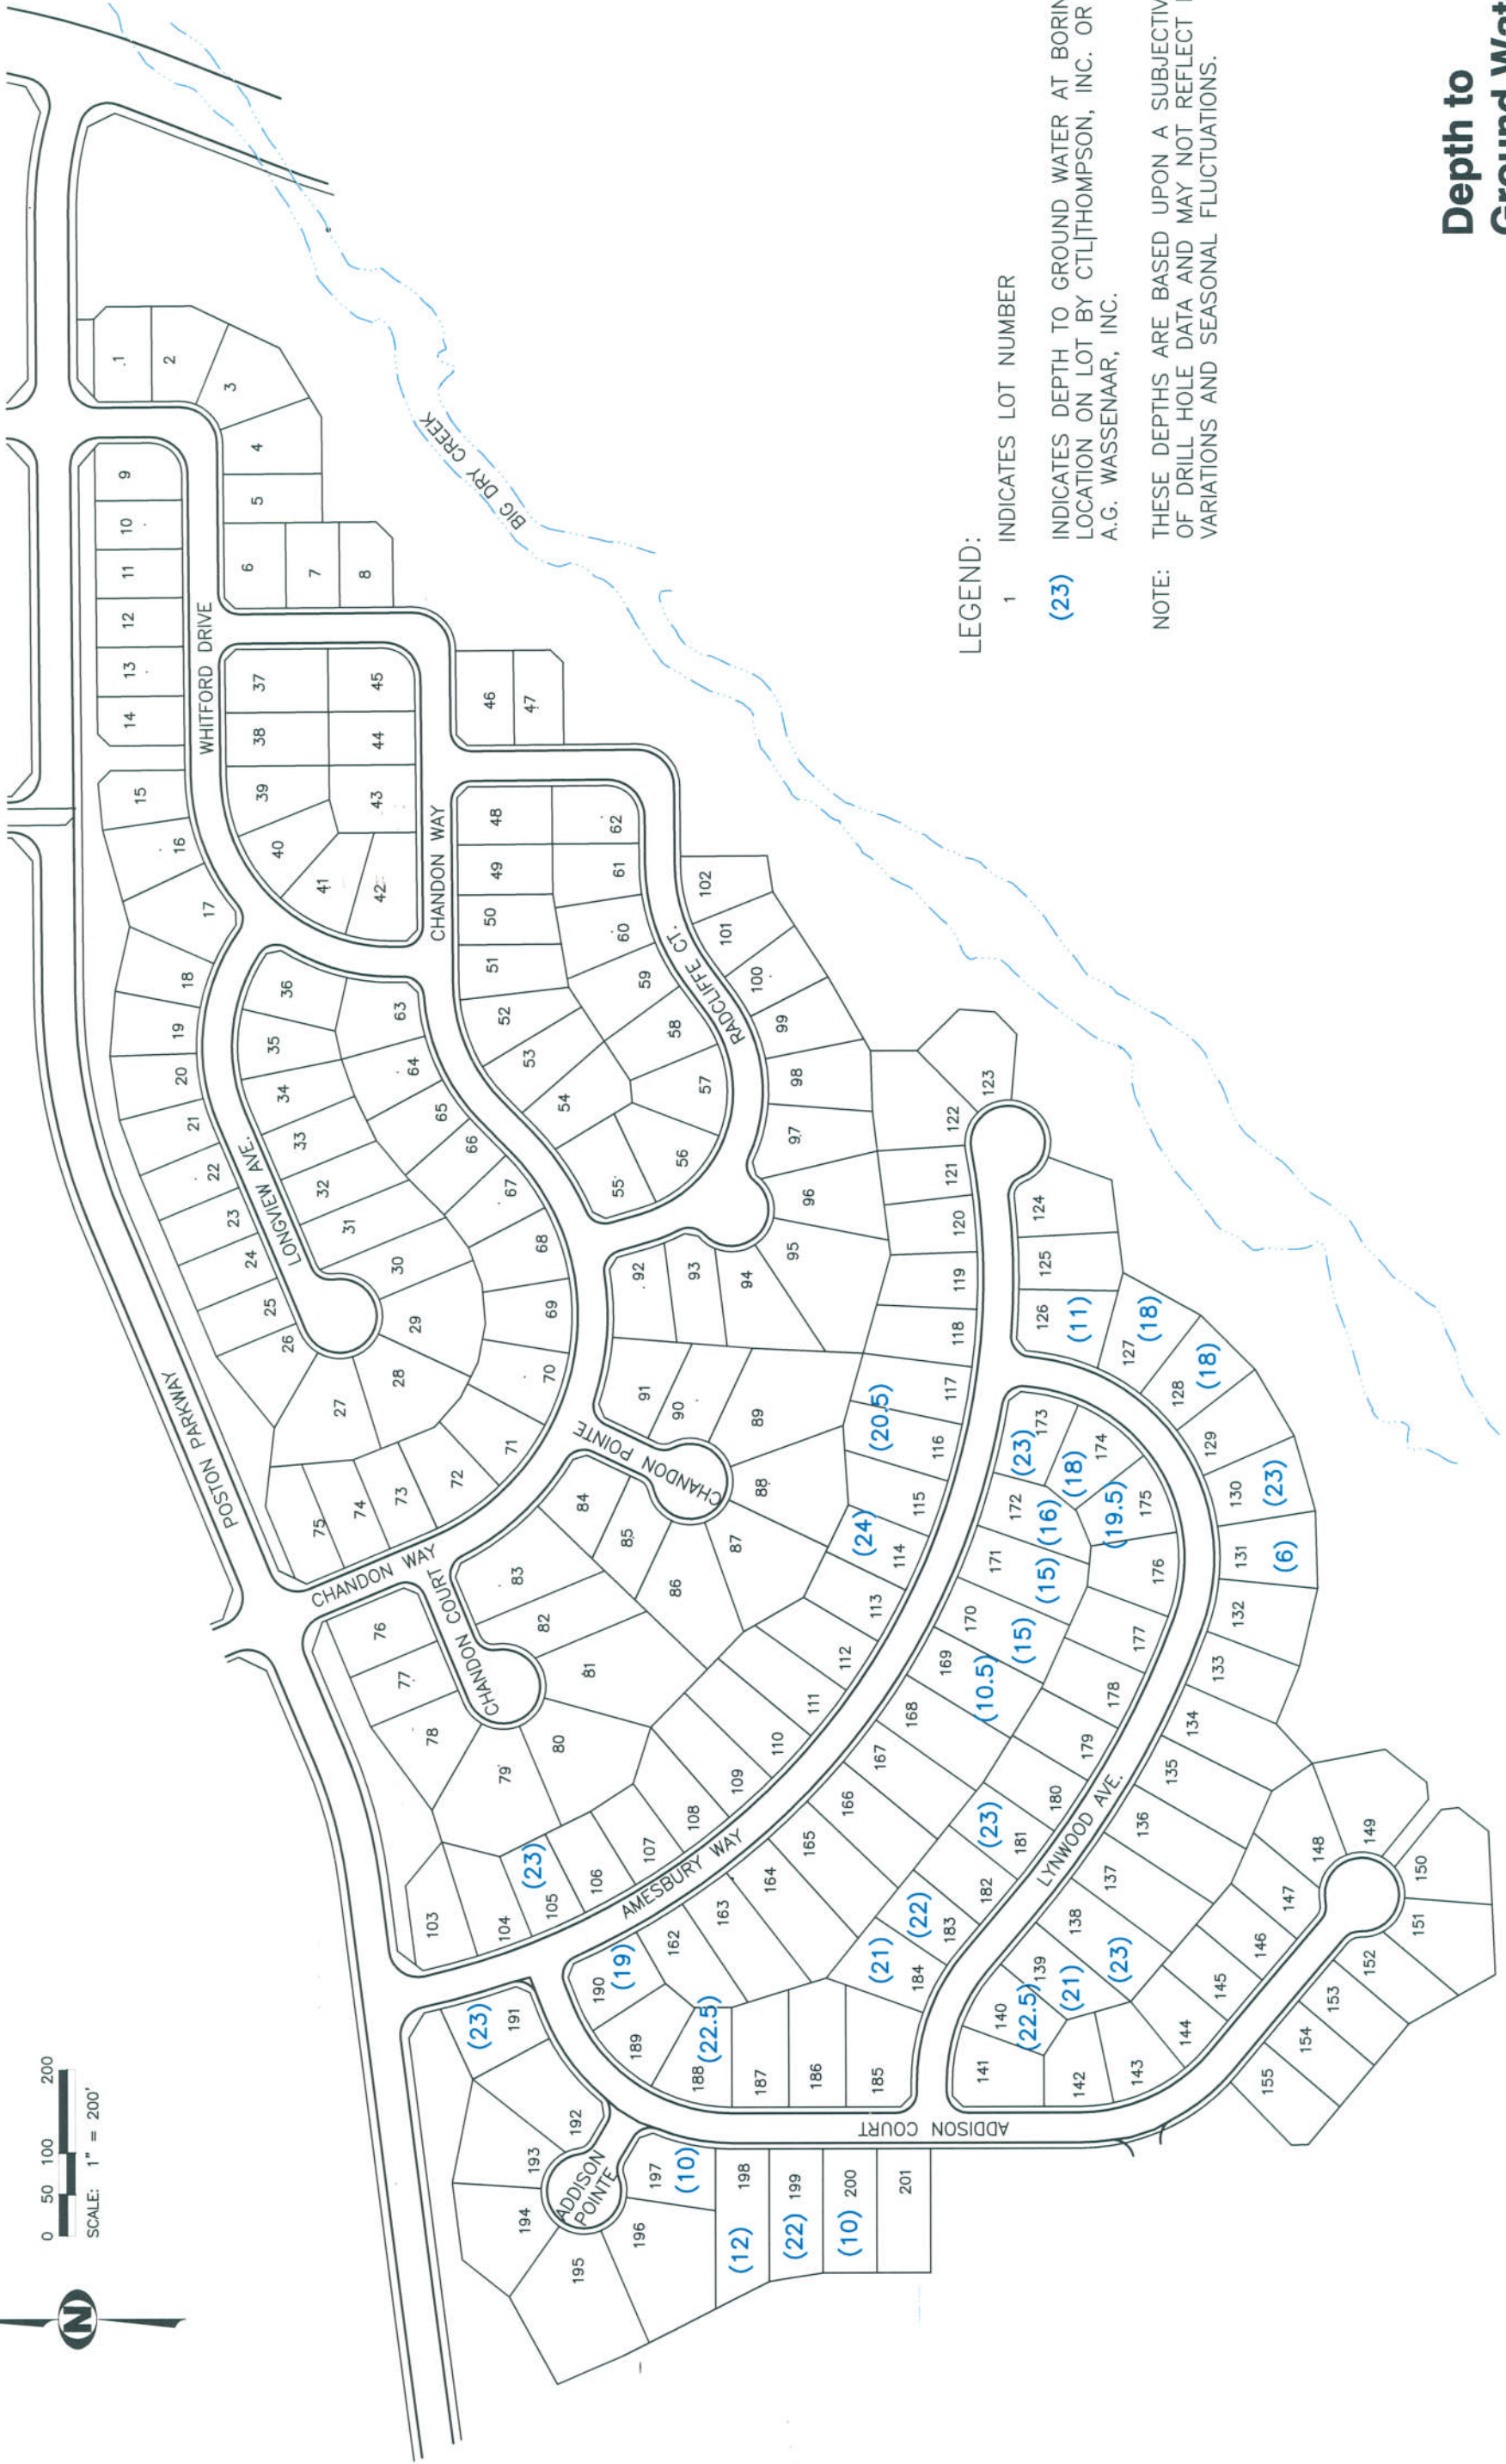
Depth to Ground Water

Unlike the lots to northeast, ground water was encountered under some lots in the southwestern half of the site. A.G. Wassenaar encountered water in 28 borings at depths of 6 to 24 feet below ground surface during their investigation after site grading. The ground water measurements performed by A.G. Wassenaar indicate that ground water is predominantly below the bedrock surface (Figs. 3 through 6). It appears the water was flowing within the bedrock to the north and northeast. Our experience indicates ground water may flow or "perch" in comparatively permeable sandstone and above less permeable claystone bedrock surface. Where bedrock daylight to the surface as the result of site grading, it is possible ground water may seep out of the cut slopes, and contribute to surface runoff. We were not able to observe seepage as the slopes were covered by both landscaping and retaining walls.
