August 16, 2007

**Douglas County Public Works
100 3rd Street
Castle Rock, Colorado 80104**

**Subject: Preliminary Findings
Geotechnical Consultation
Surface Drainage and Sidewalk Chase Drains
Highlands Ranch Filing No. 122-U
Highlands Ranch, Colorado
Project No. DN42,518-145**

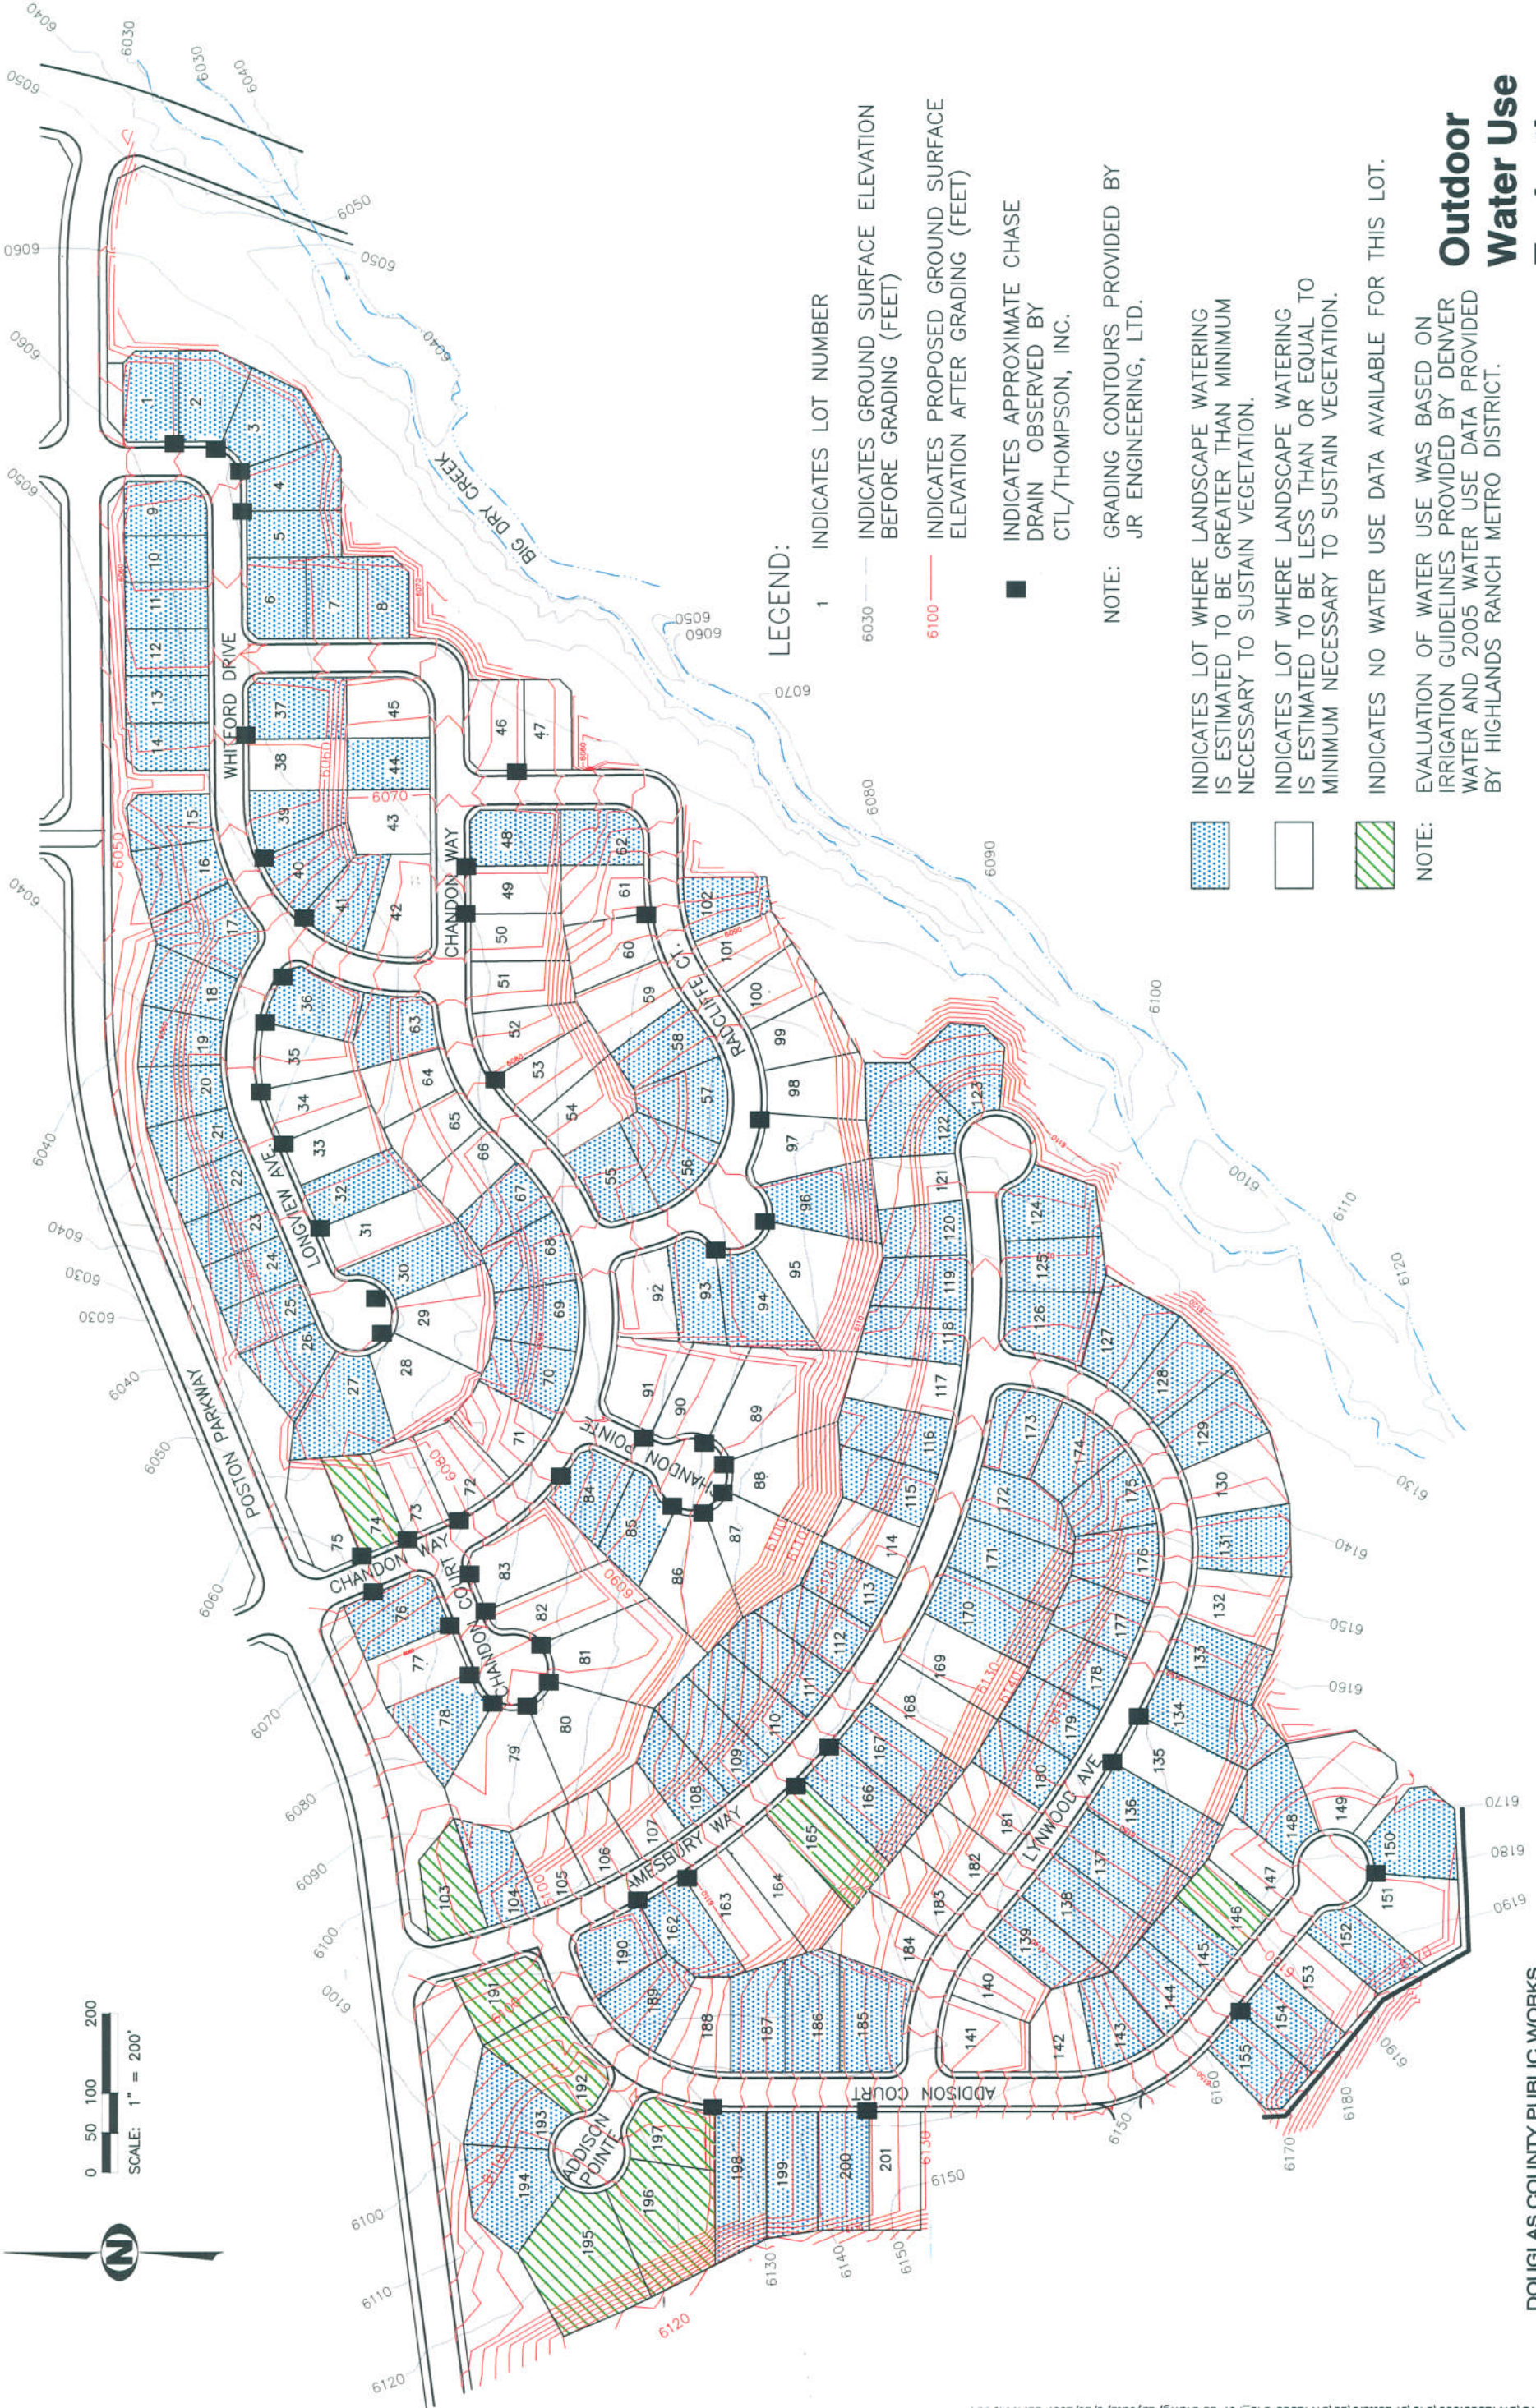
Estimated Ground Water Elevation

- 1.) THESE CONTOURS ARE BASED UPON A SUBJECTIVE ANALYSIS OF DRILL HOLE DATA AND MAY NOT REFLECT LOCAL VARIATIONS AND SEASONAL FLUCTUATIONS.
- 2.) GROUND WATER CONTOURS ARE NOT CONTINUOUS.
